Buy Right Home Inspections

Report # : 1234120112

Subject Property

1234 Main St

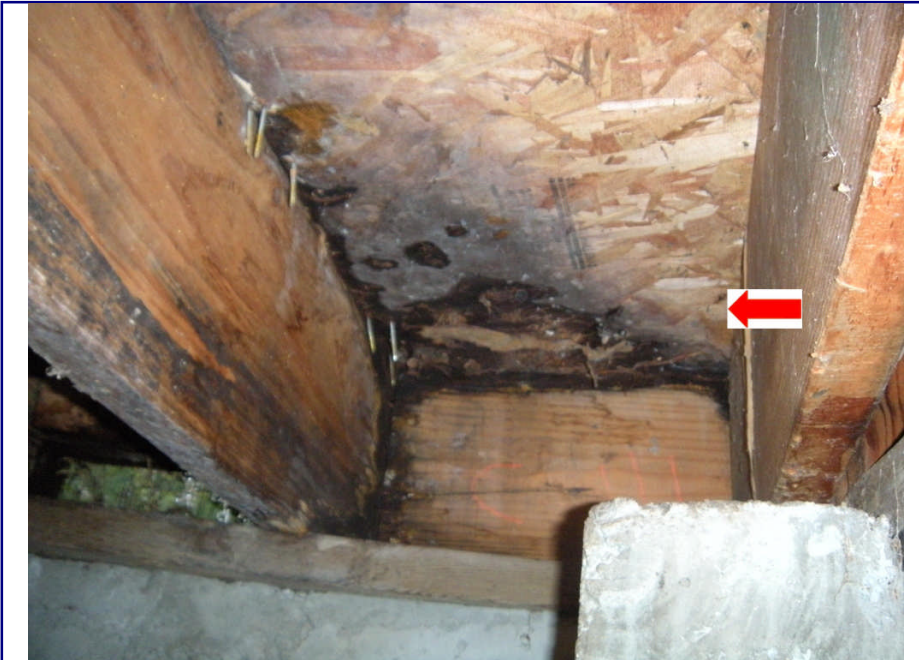
Picture 1

Comments: The metal drip edge flashing at the main rear patio is not sealed to the concrete allowing water to roll around onto the wood decking causing moisture damage below. (3)(Refer to picture number 1 on page 18) The concrete patio off the 4th bedroom is leaking water onto the wood decking below near the dining nook/house connection. (3)(Refer to picture number 2 on page 18) The rear patios are

The metal drip edge flashing at the main rear patio is not sealed to the concrete allowing water to roll around onto the wood decking causing moisture damage below. (3)

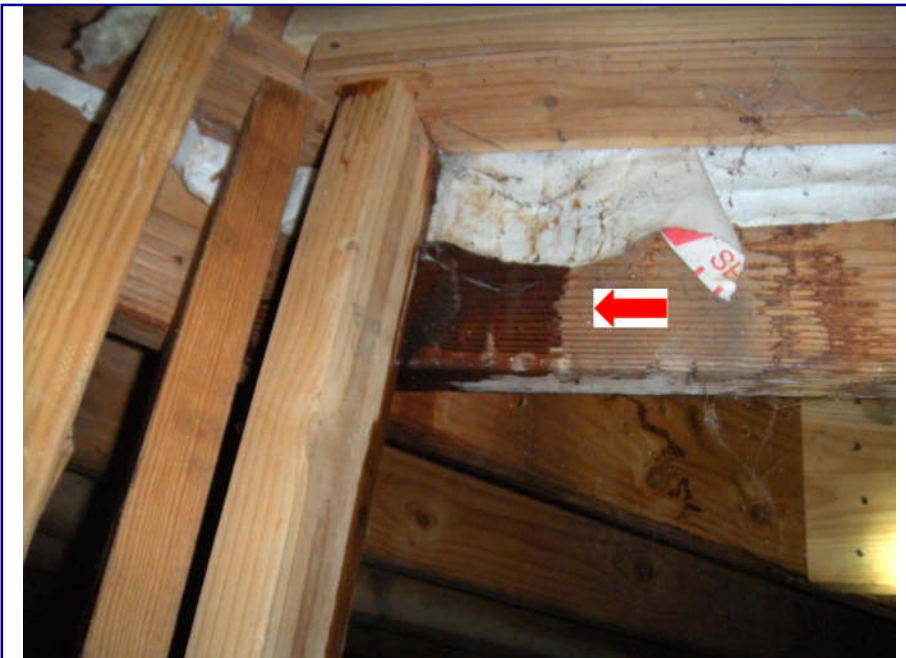
Picture 2

The concrete patio off the 4th bedroom is leaking water onto the wood decking below near the dining nook/house connection. (3)

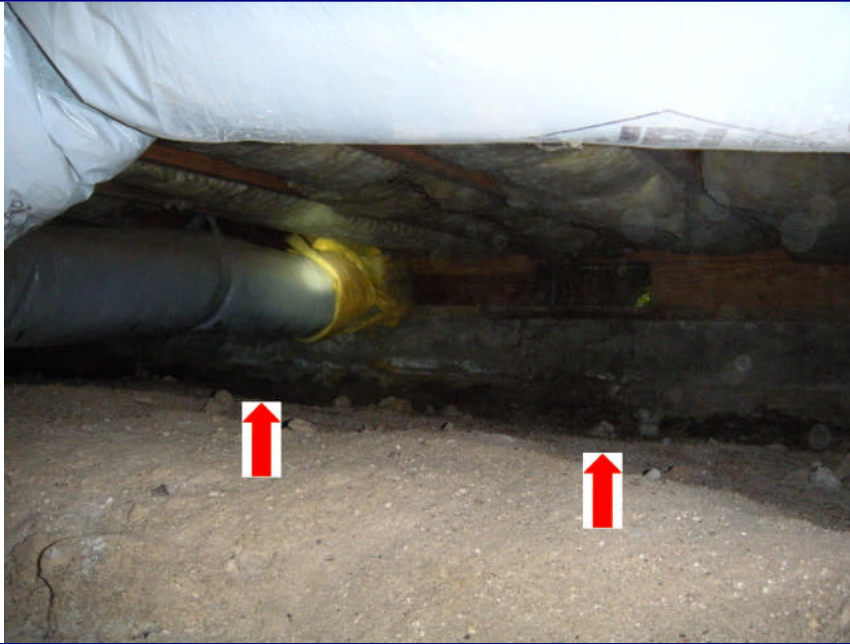
Picture 3

Comments: The front gutters are allowing water to drain over into the front planter bed below the living room and dining room windows; this area is over saturated causing moisture at the foundation and soil in the crawl space behind this area. (Refer to picture number 3 on page 19)

The front gutters are allowing water to drain over into the front planter bed below the living room and dining room windows; this area is over saturated causing moisture at the foundation and soil in the crawl space behind this area.

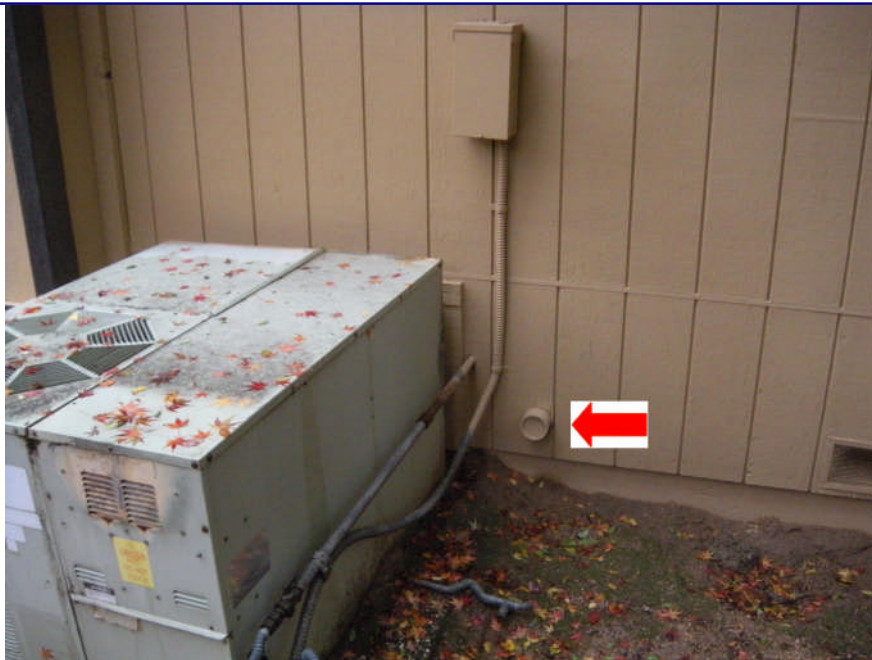
Picture 4

The waste line clean out cap on the right side of the house is not a removable, permanent type; this is the construction test cap left in place. *

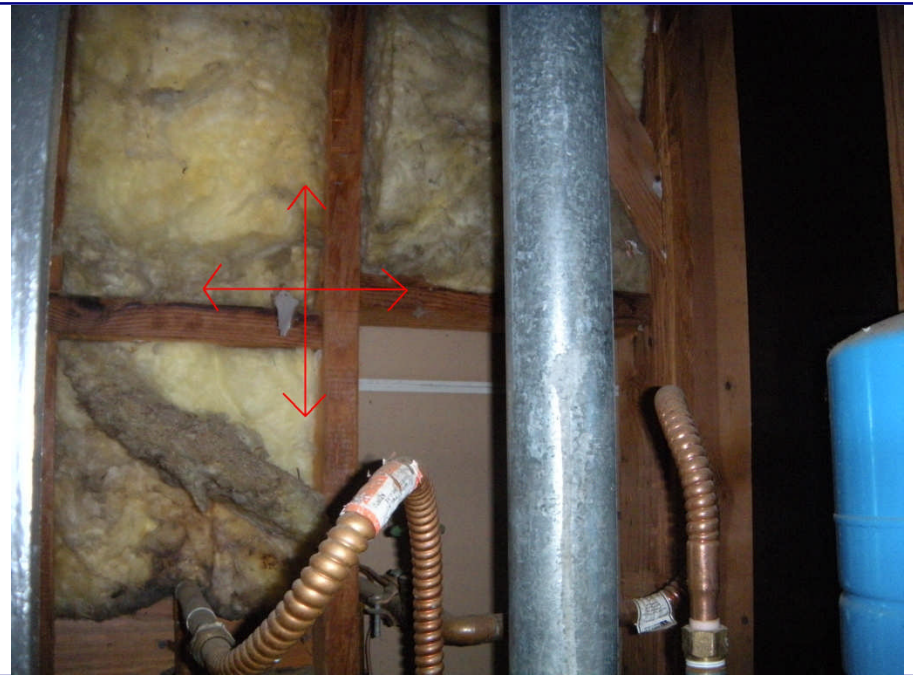
Picture 5

Comments: The right side water heater closet is missing the firewall at the wall leaving the interior wall and attic exposed. (2)(4)(Refer to picture number 5 on page 20)

The right side water heater closet is missing the firewall at the wall leaving the interior wall and attic exposed. (2)(4)

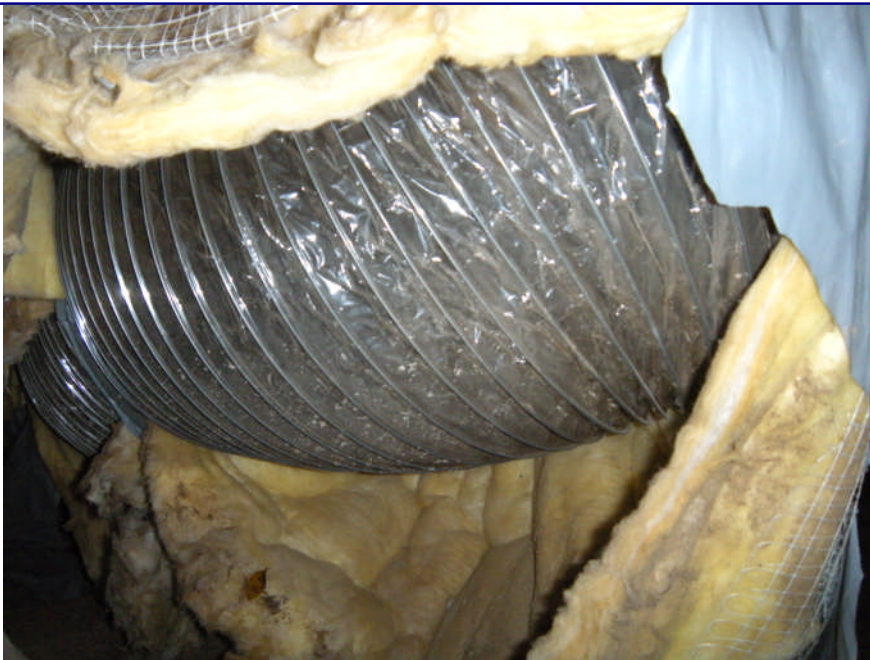
Picture 6

The exterior coating is damaged allowing the insulation to partially fall off various HVAC ducts in the crawlspace; recommend repairing as necessary.

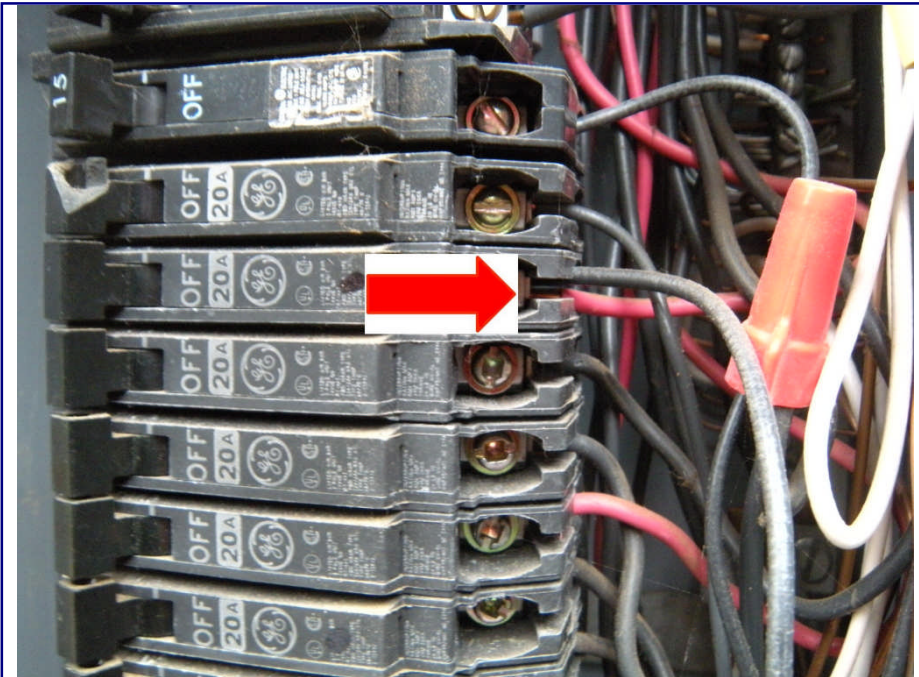
Picture 7

Two wires are connected to one breaker and one of these wires is too small for the breaker size in the main electrical panel. (2)(4)

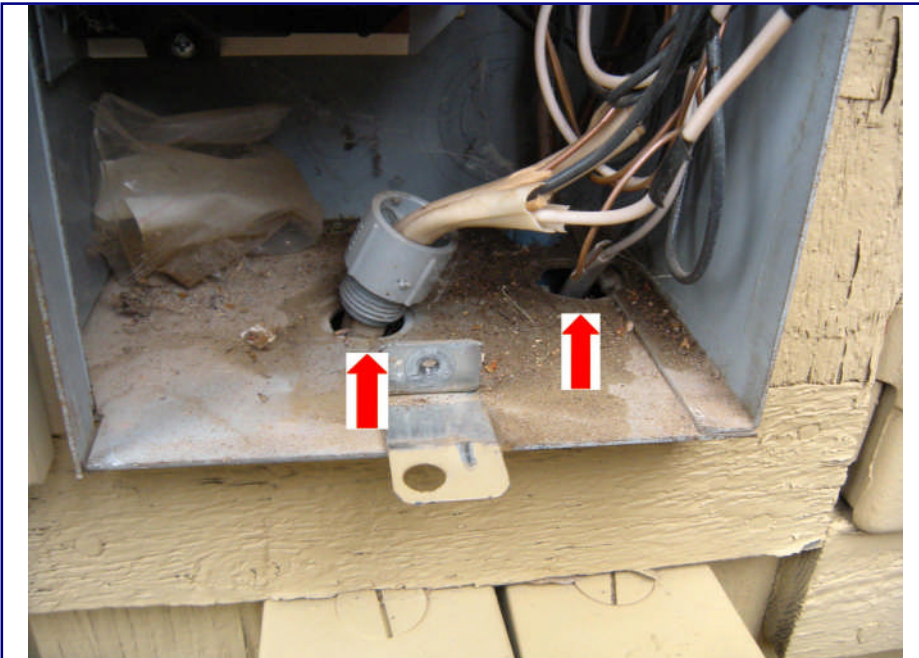
Picture 8

Wires pass through unprotected openings in the bottom of the main electrical panel. (2)(4)

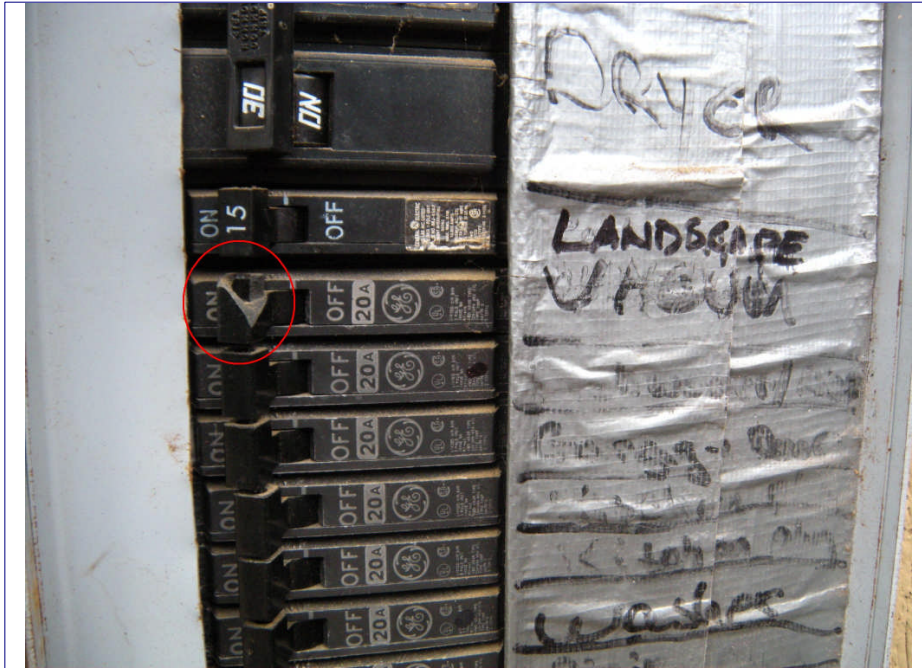
Picture 9

The 20 amp breaker labeled "VACUUM" is damaged in the main electrical panel. (2)(4)

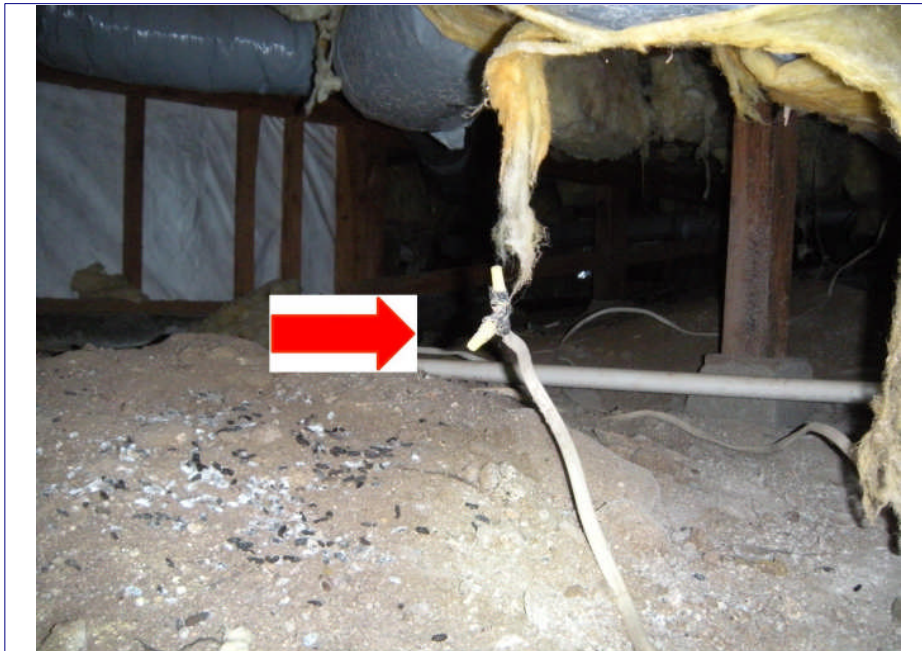
Picture 10

Exposed wires were found at the rear patio near the pool light switch conduit and in the crawl space in the area below the kitchen; these are required to terminate inside a covered junction box. (4)

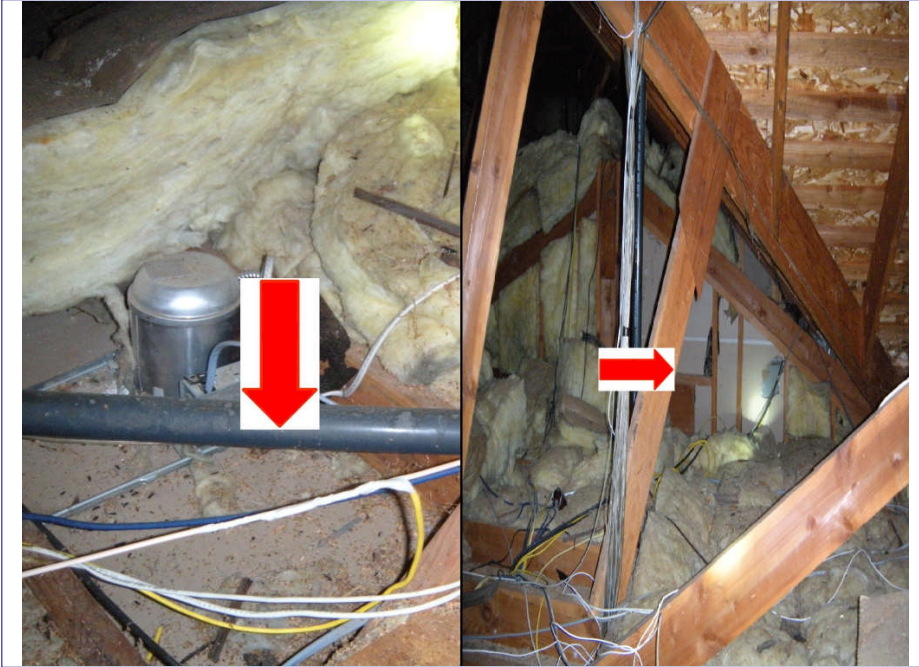
Picture 11

The attic insulation has been moved aside in various areas of the attic leaving areas uninsulated.

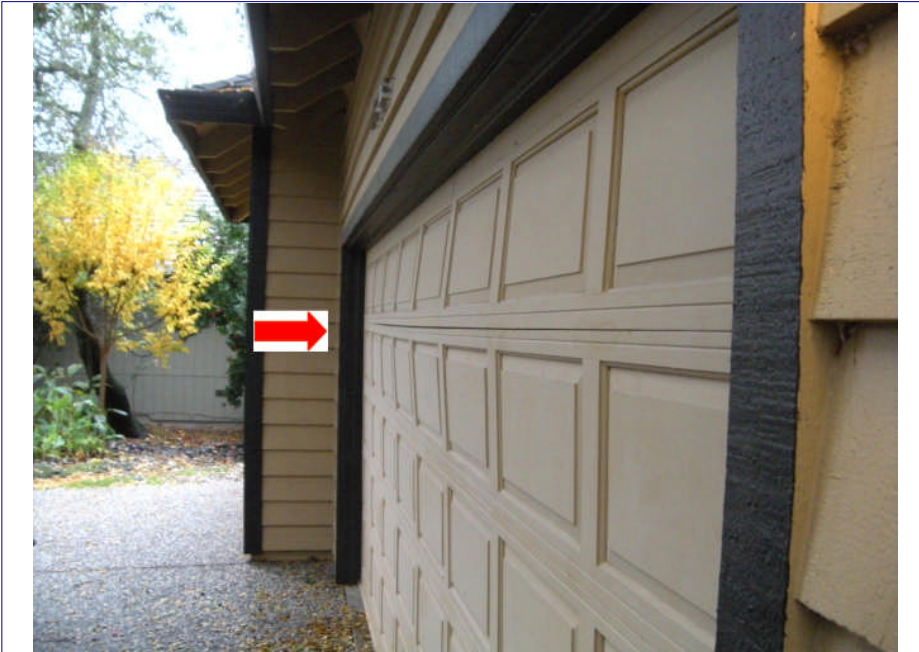
Picture 12

The two car garage vehicle door is buckled near the top; recommend further evaluation and repairs by a licensed garage door contractor. (2)

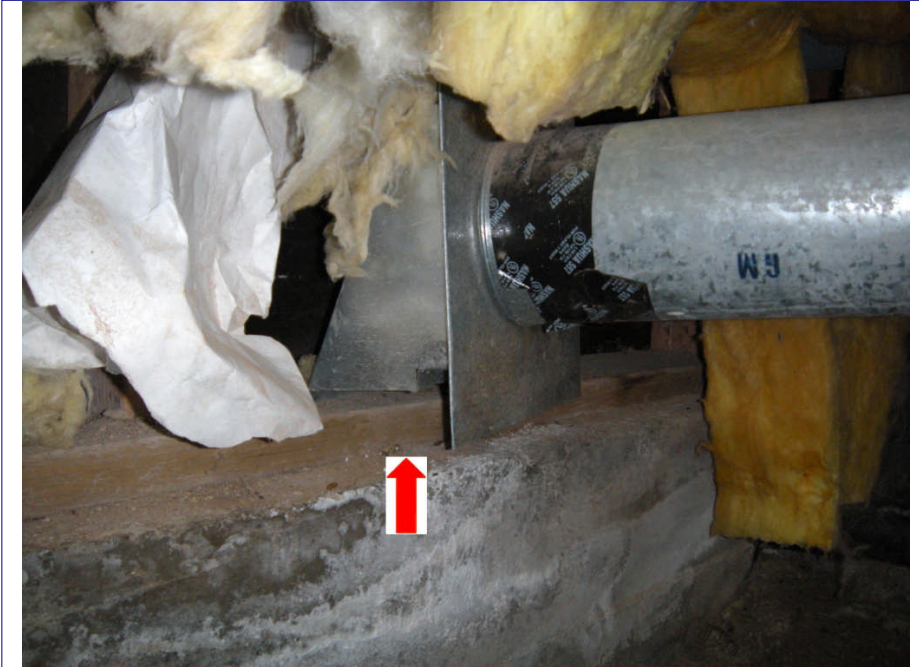
Picture 13

The down draft ducting improperly terminates in the crawl space; this is required to terminate at an exterior location. (2)

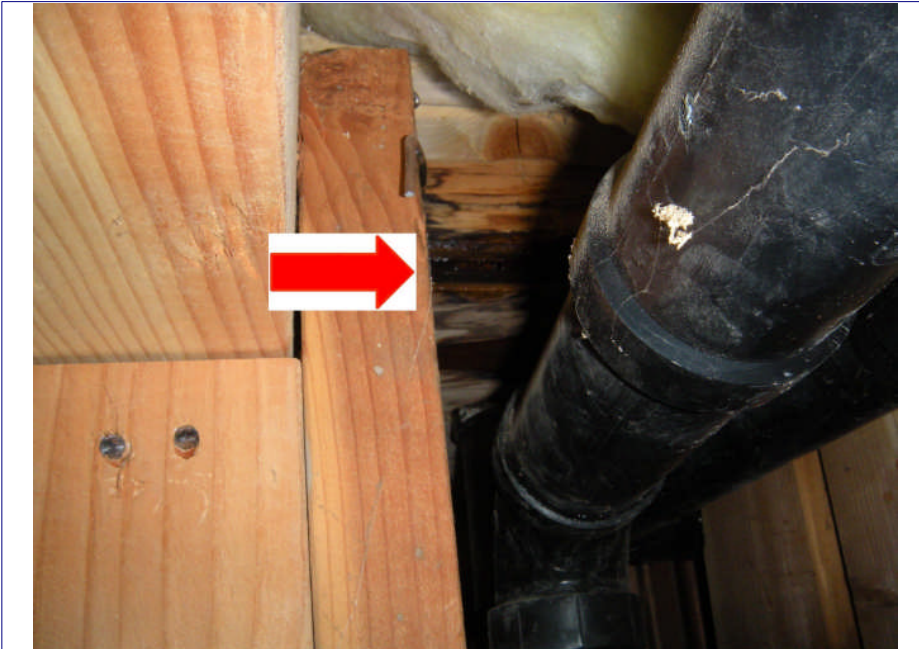
Picture 14

The master bathroom shower drain is leaking in the crawl space; recommend sealing the drain troth to stop the leaking. (2)(3)
